An Taisce
The National Trust for Ireland

Buildings at Risk

November 2014

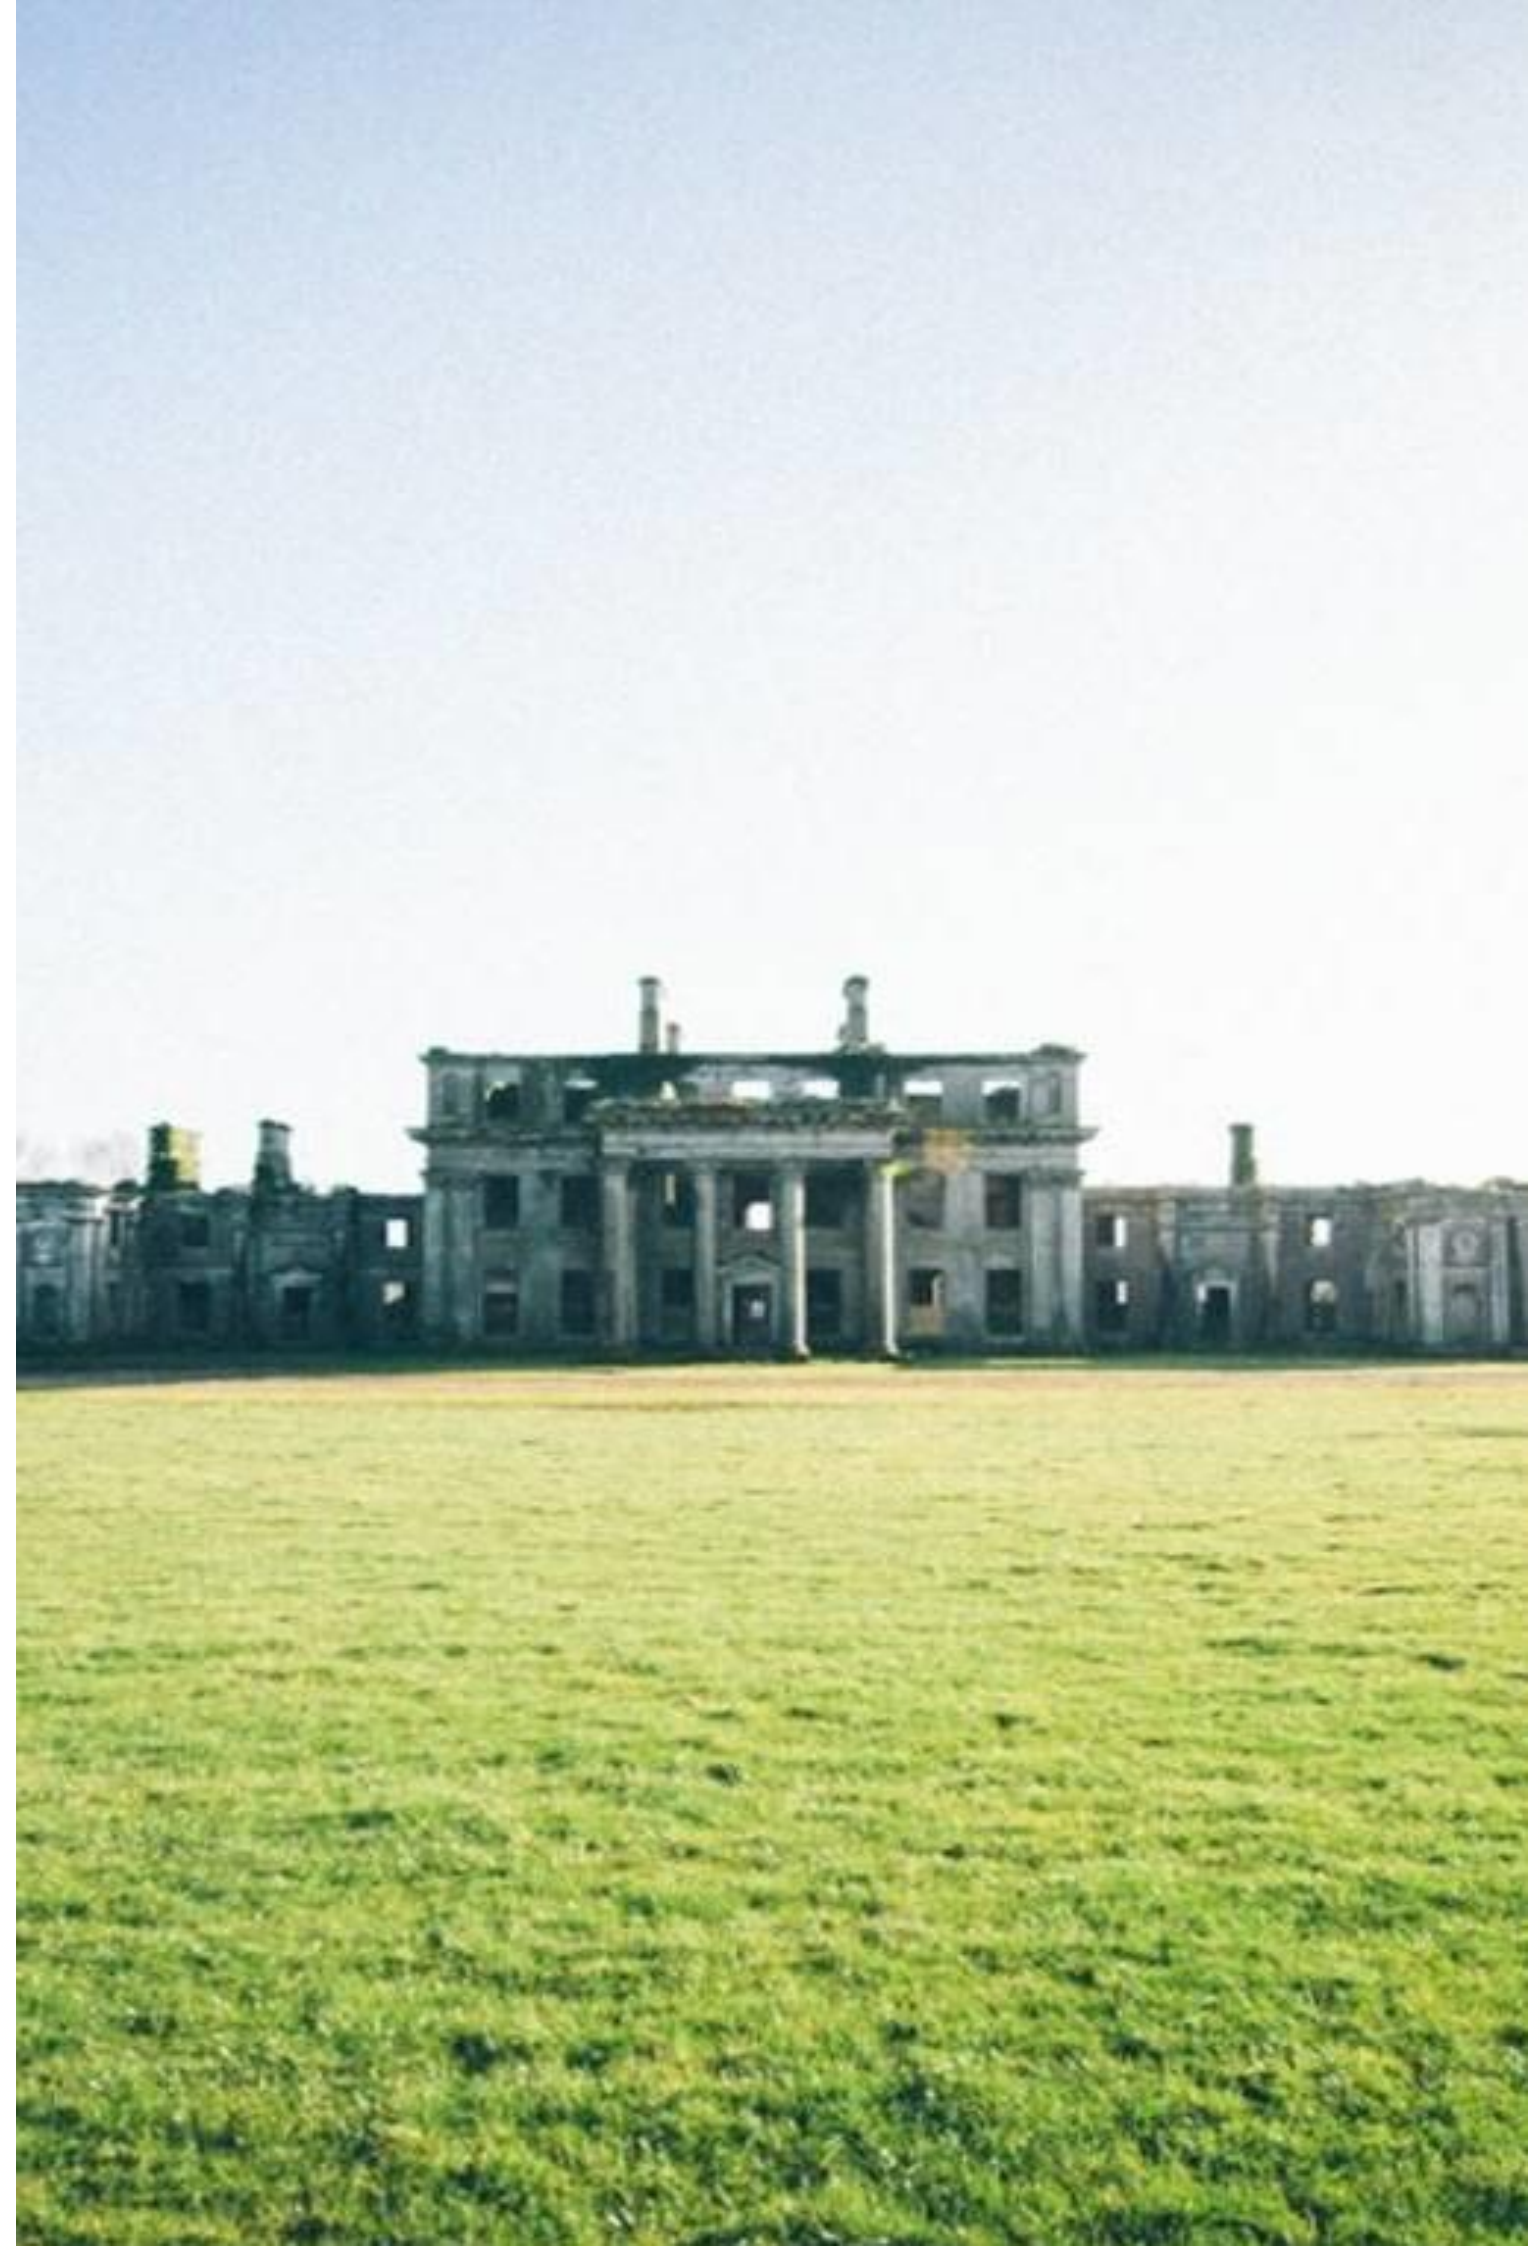
Castleboro House

Vacant with no identified new use	
Suffering from neglect and/or poor maintenance	X
Suffering from structural problems	
Fire damaged	
Threatened with demolition	
Ruin which is poorly maintained	X

Condition of Structure	Poor
Level of Risk	Moderate

The building is a roofless shell. None of the original fabric remains other than the external walls. It is suffering from structural problems that could lead to full or partial collapse, and there is an immediate threat of further deterioration.

A classical house of circa 1840, designed by Daniel Robertson, for first Lord Carew. The building is three storey with seven bays and the central block holds a two storey Corinthian porte cochere to front and canted bay to garden front facing onto River Boro. The structure is of significant historic importance and requires conservation works to prevent further deterioration.

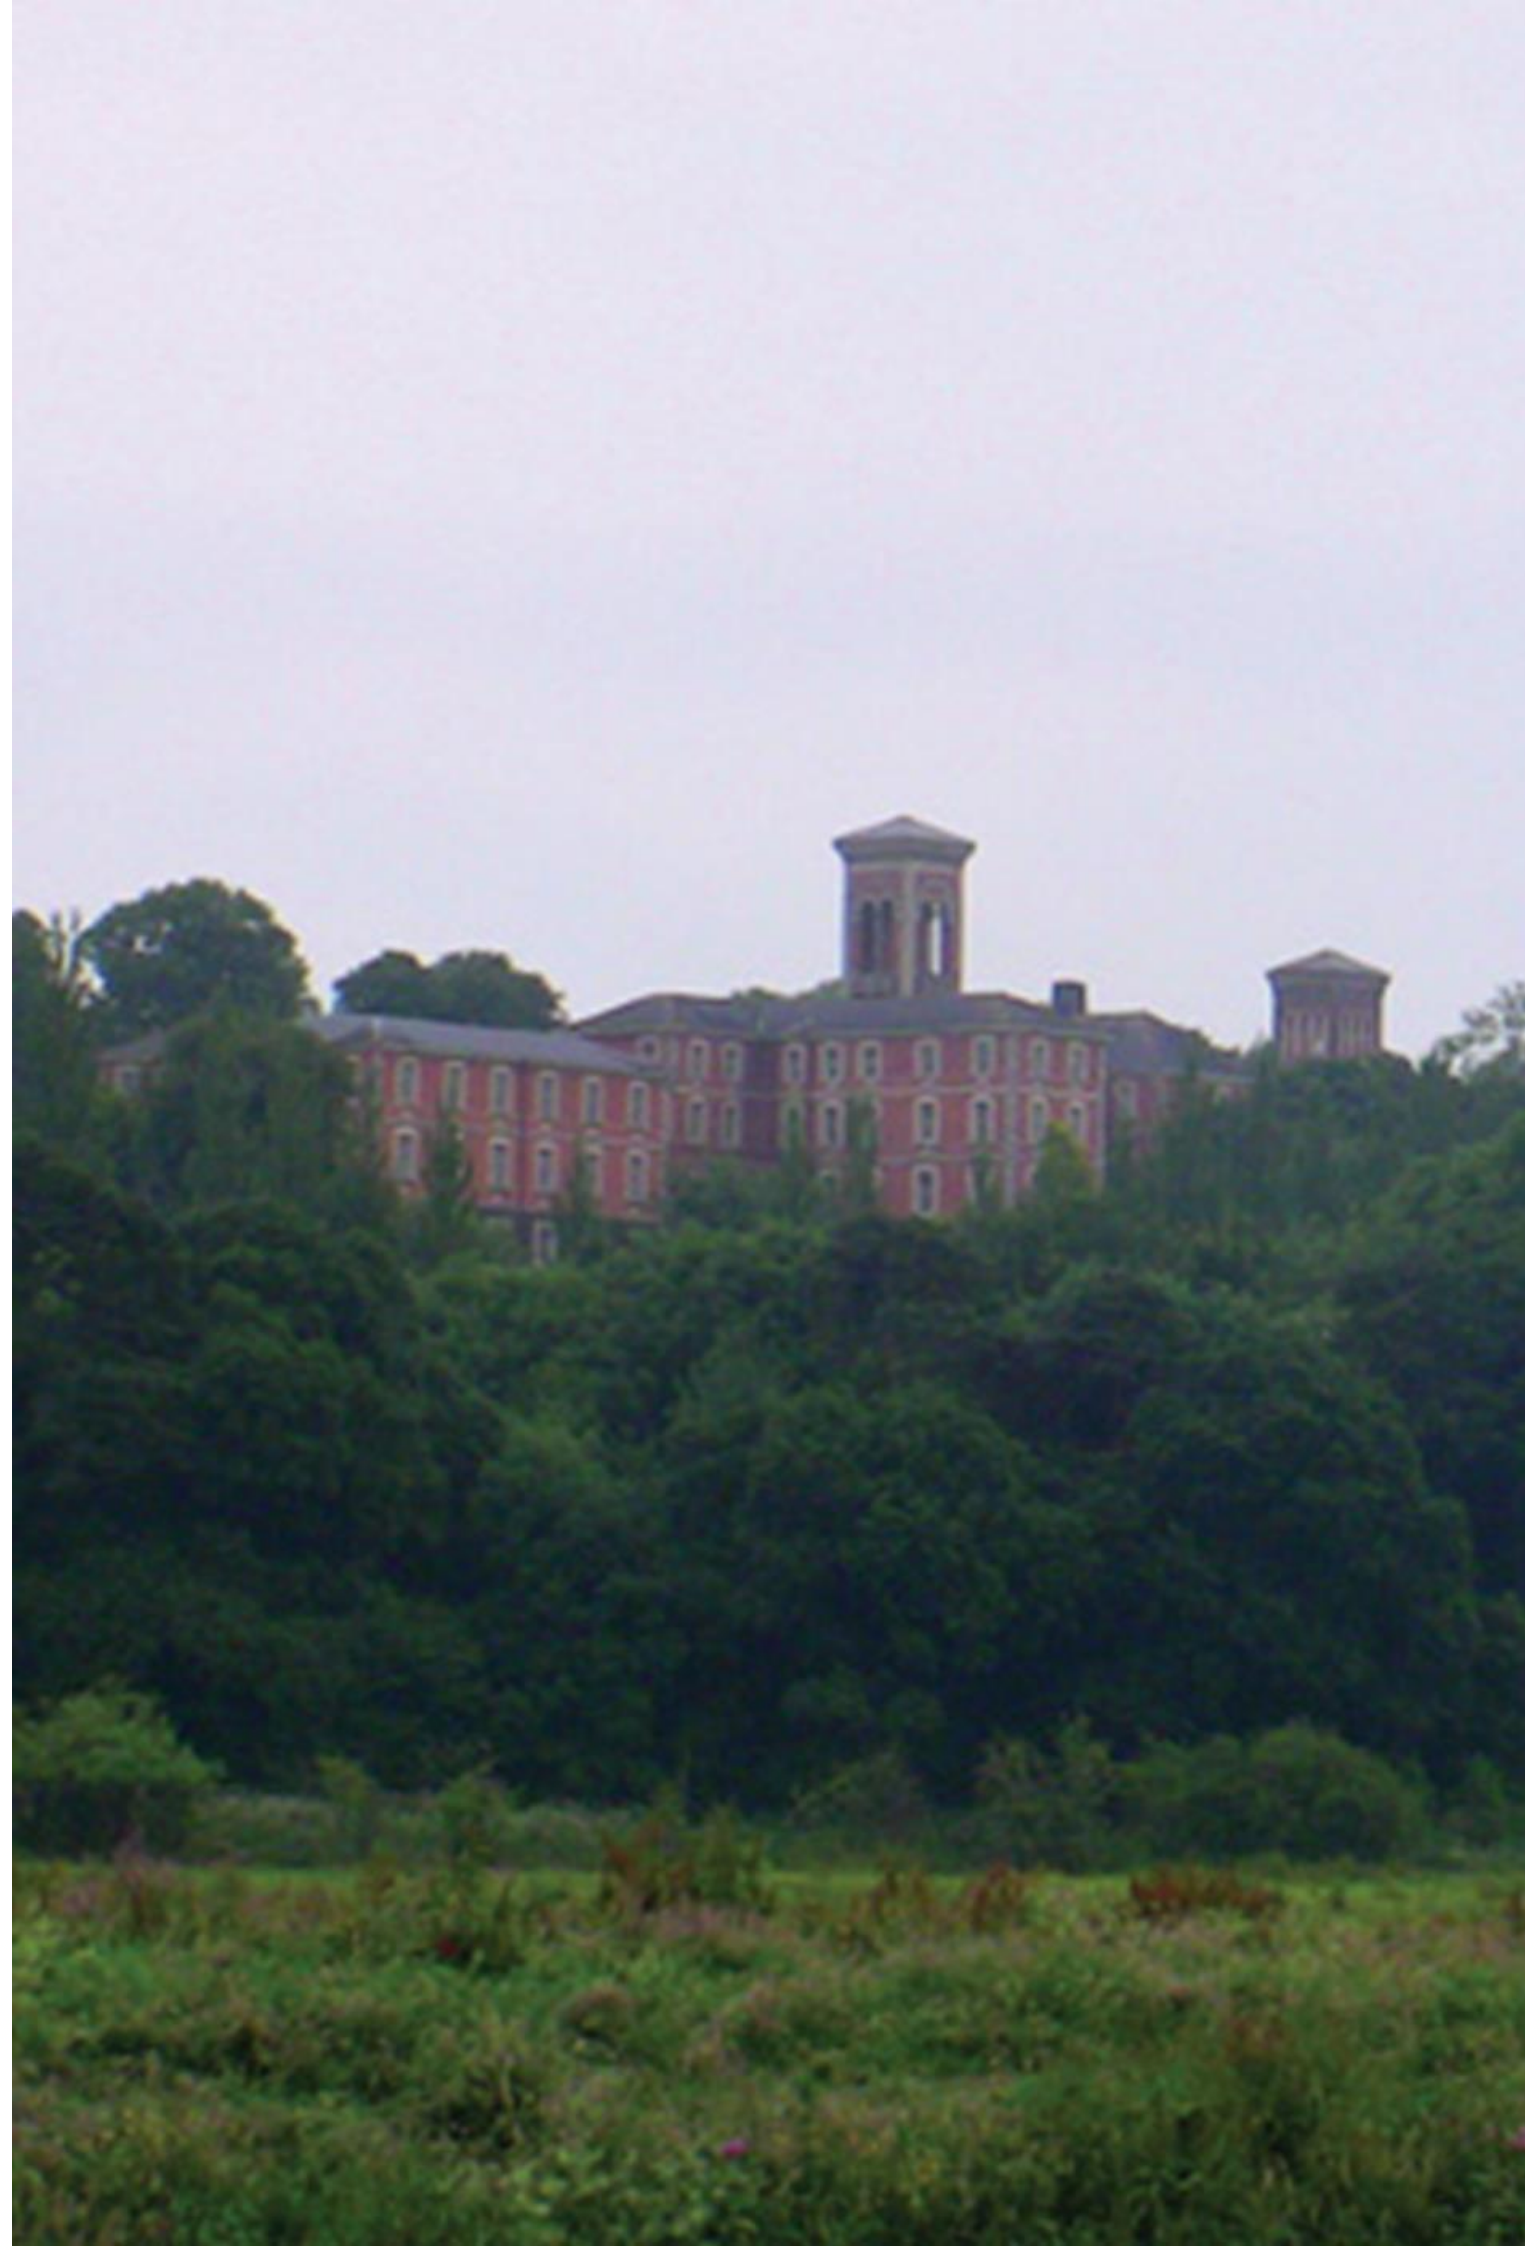
St Senan's Hospital

Vacant with no identified new use	X
Suffering from neglect and/or poor maintenance	X
Suffering from structural problems	
Fire damaged	
Threatened with demolition	
Ruin which is poorly maintained

Condition of Structure	Poor
Level of Risk	High

This building has been vacant for a number of years and does not appear to be maintained. Most of the external fabric remains, but there are obvious signs of deterioration, particularly water penetration, slipped slates, vegetation growth, broken windows and vandalism. There is no immediate danger of collapse but the condition is such that unless urgent remedial works are carried out the building will sharply deteriorate.

St Senans is one of the most impressive 19th century institutional buildings in the country and is considered of national significance in the National Inventory of Architectural Heritage. Its prominent location makes St Senan's a major landmark in the Slaney Valley, south of Enniscorthy. Its construction is of high quality with four brick towers which makes it visible across a wide area. The building presents one of the most difficult new use challenges in the country.

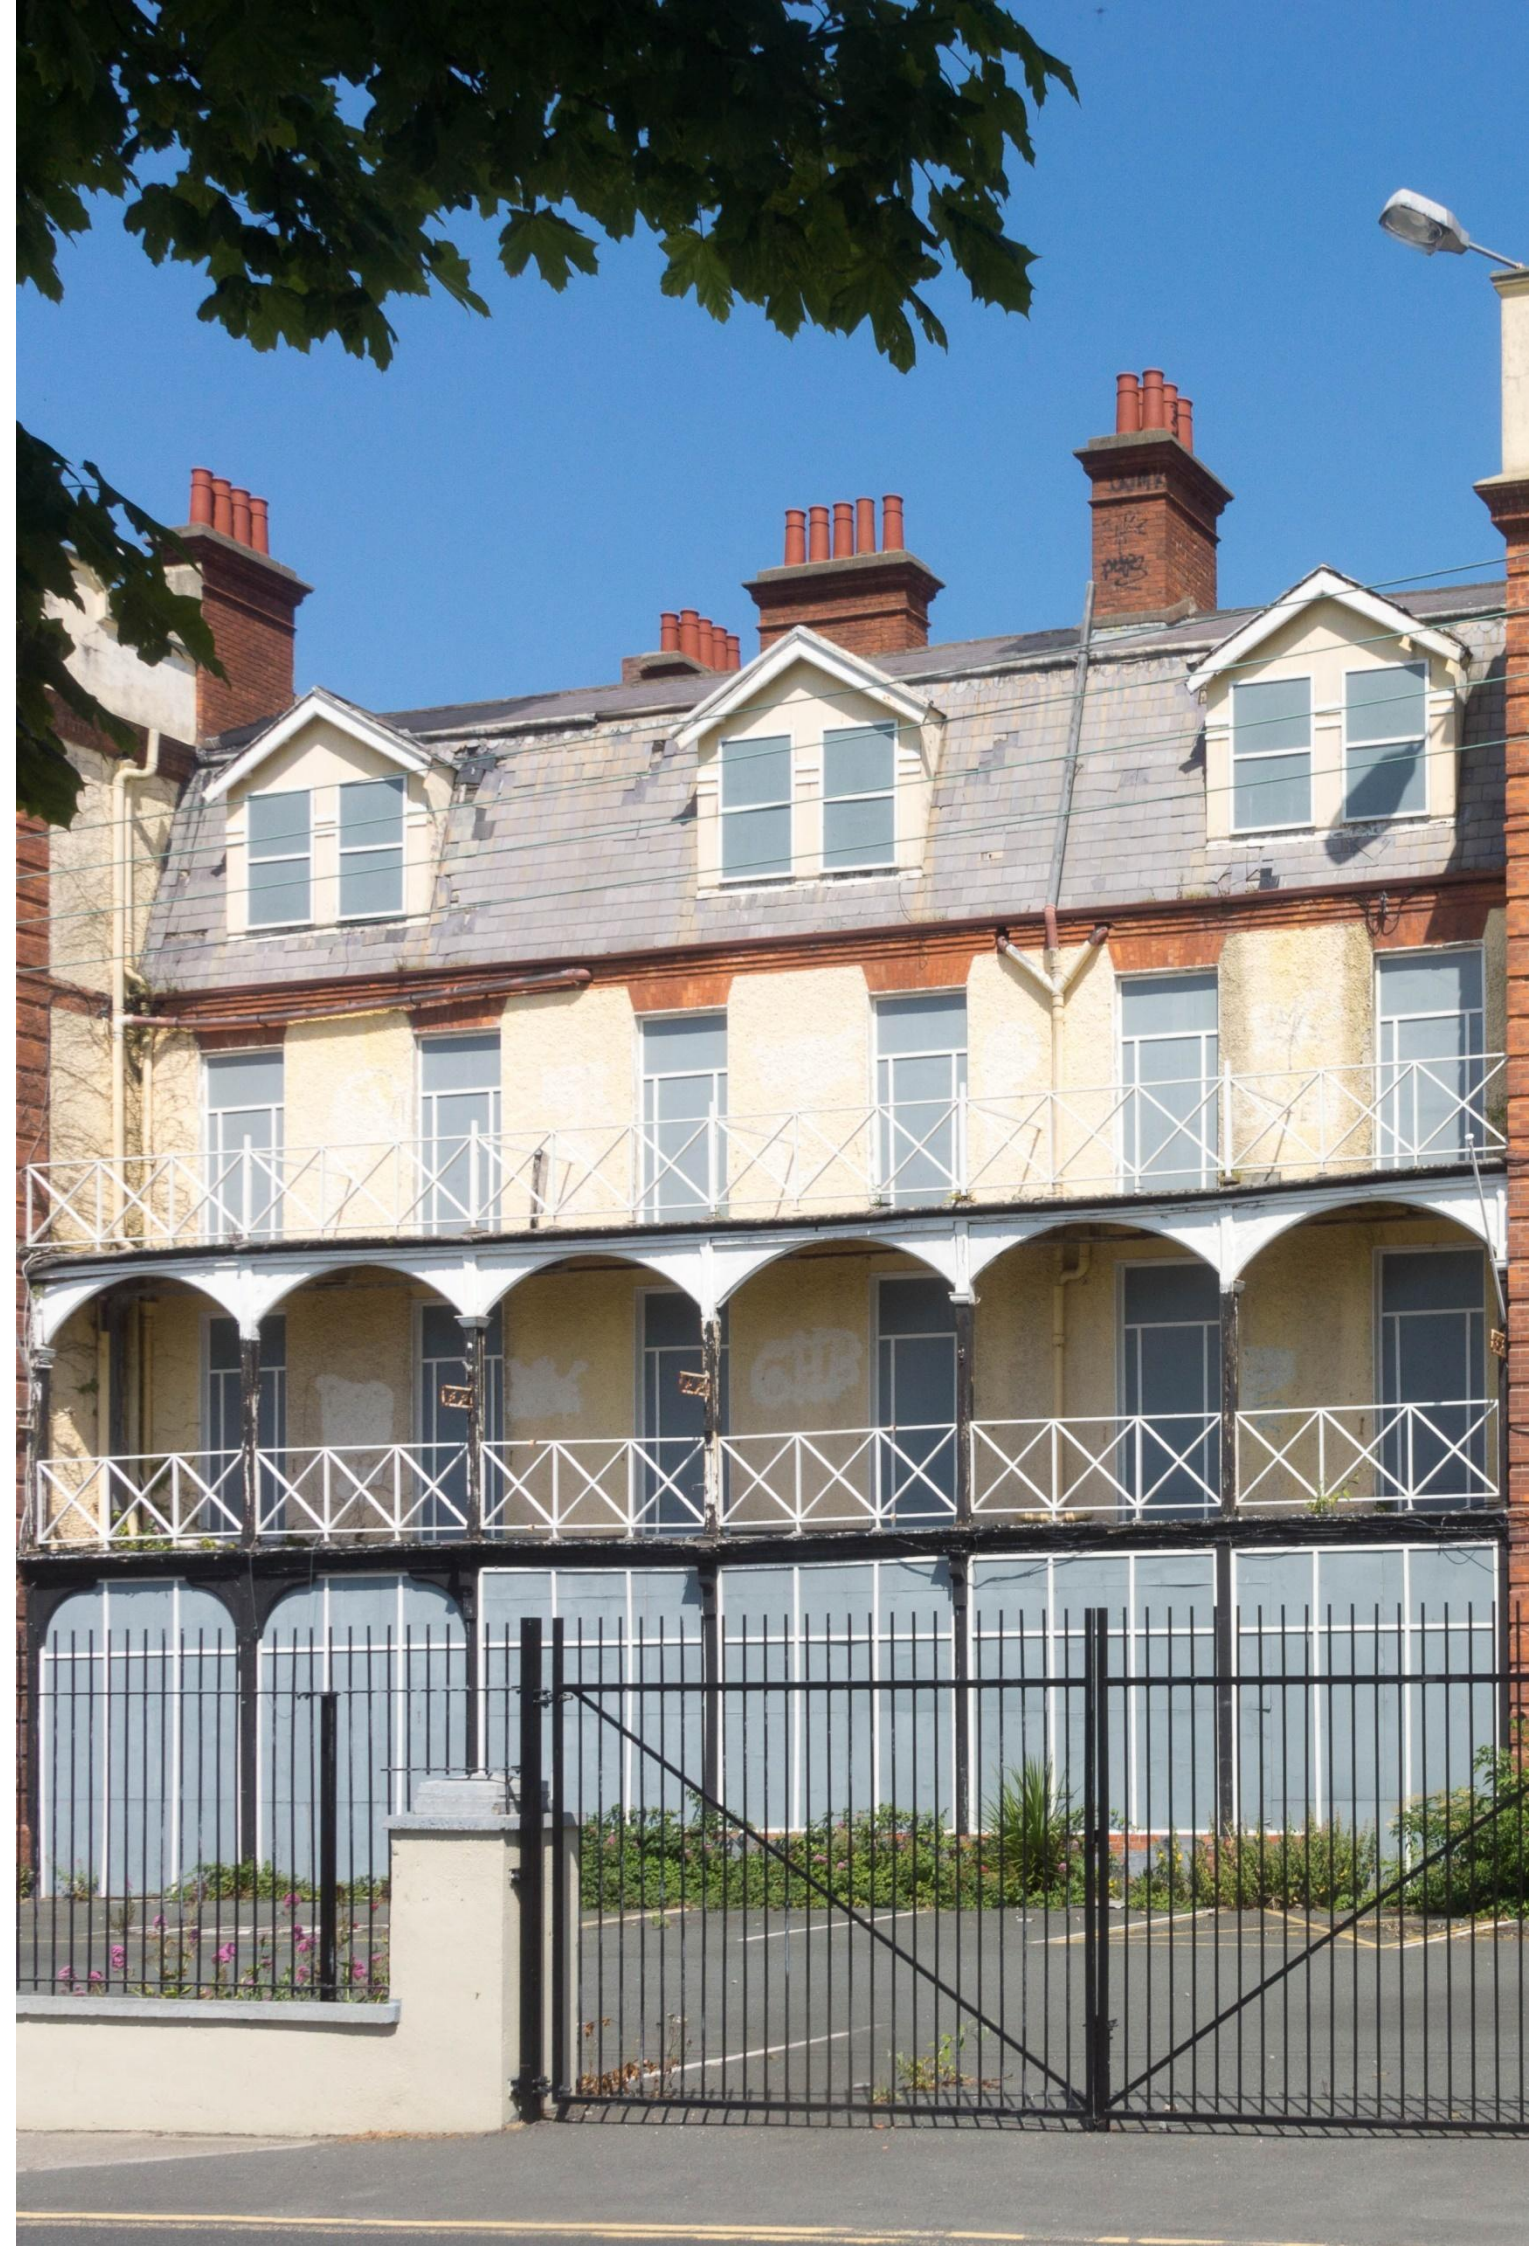
Le Touché Hotel

Vacant with no identified new use	X
Suffering from neglect and/or poor maintenance	X
Suffering from structural problems	
Fire damaged	
Threatened with demolition	
Ruin which is poorly maintained

Condition of Structure	Poor
Level of Risk	High

This building has been vacant for a number of years and does not appear to be maintained. Most of the external fabric remains, but there are obvious signs of deterioration, particularly water penetration, slipped slates, vegetation growth, broken windows and vandalism. There is no immediate danger of collapse but the condition is such that unless urgent remedial works are carried out the building will sharply deteriorate.

The former La Touché Hotel in Greystones, Co Wicklow is a Protected Structure built circa 1900 to designs by McCurdy & Mitchell following the arrival of the railway. The ground floor section below the balconies is now filled with replacement windows and entrance screens. NAMA currently holds the loans for the property and has released some funds for its maintenance. This building urgently requires new uses to be identified to prevent further deterioration of its character.
